Maintenance Actions to Address Fatigue Cracking in Steel Bridge Structures

PROPOSED GUIDELINES AND COMMENTARY

NCHRP Transportation Research Board of
The National Academies

Robert J. Connor and Jason B. Lloyd
Purdue University
West Lafayette, Indiana

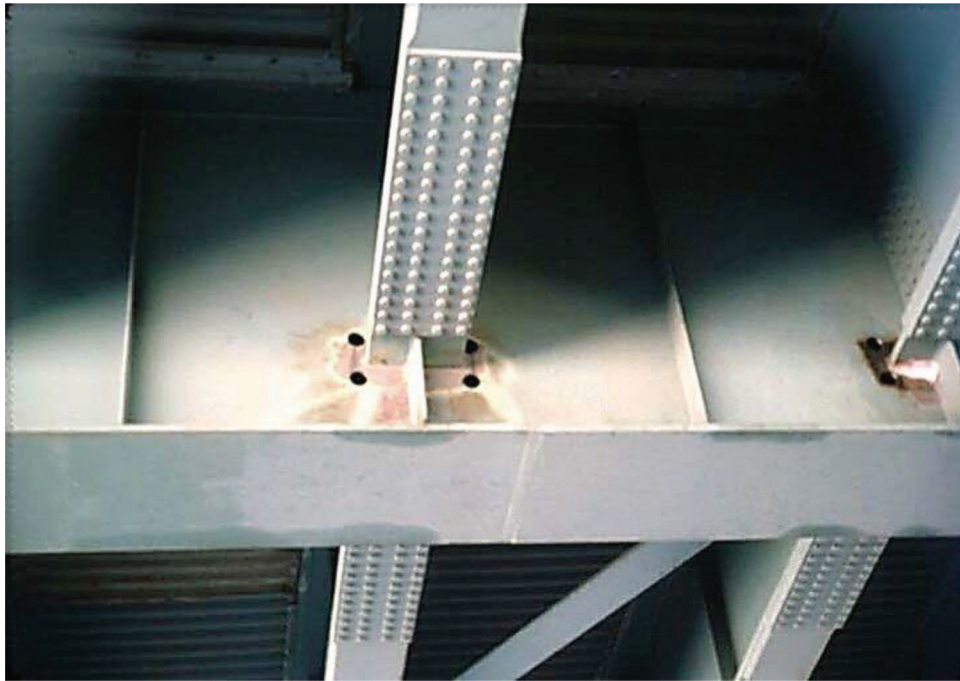
Figure 6.38 Completed dog-bone retrofit on a web penetration detail.

4. Connect the centers of the two drilled holes by cutting vertically up/down the web plate using an angle grinder with cutoff wheel or a controlled thermal cutting process such as plasma cutting. If possible, make the vertical cut between the two holes pass through the flange tip weld toes. This will remove any existing cracks, as well as relieve the detail of locked-in welding residual stresses. Refer to Figure 6.37 for illustration of this detail. See Figure 6.38 for an example of the dog bone retrofit installed on the Girard Point Bridge.

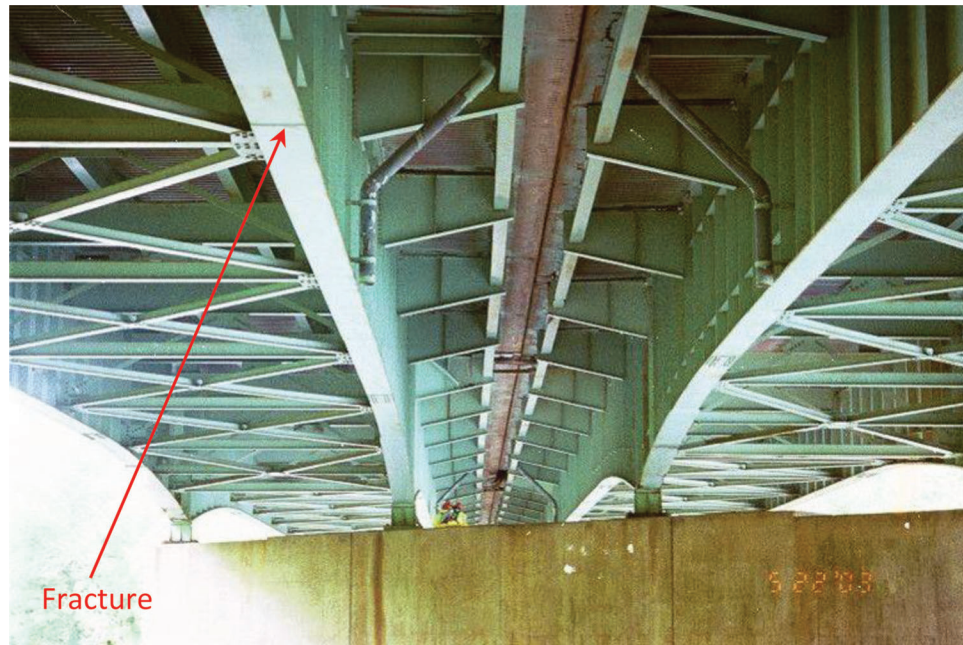
Figure 7.1 US 422 Bridge fracture discovered in 2003 during retrofitting.

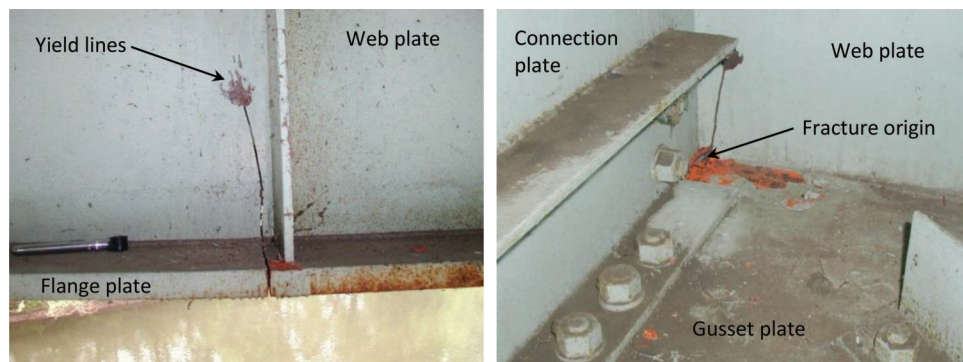
Figure 7.2 US 422 Bridge fracture that arrested in the web.

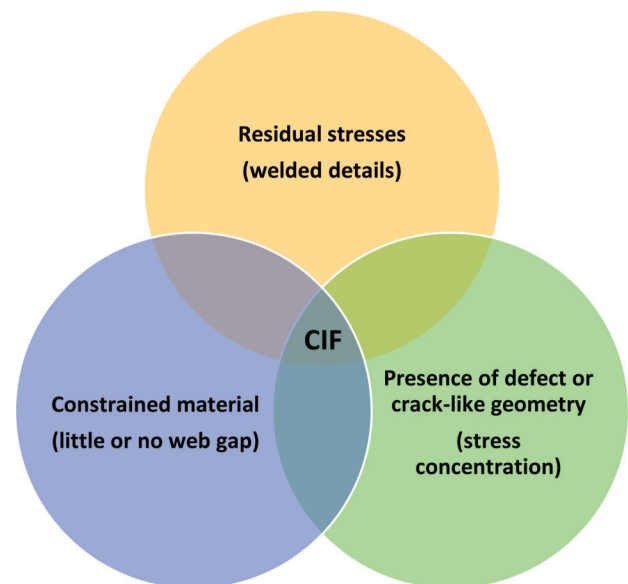
Figure 7.3 Defining characteristics of CIF details.

There are three contributing elements to constraint-induced fracture, characteristic of all CIF-prone details, which when any one of the elements is missing, the likelihood of constraint-induced fracture drops dramatically. Figure 7.3 illustrates these elements, conceptually showing that the risk of CIF exists at the intersection of the three elements.

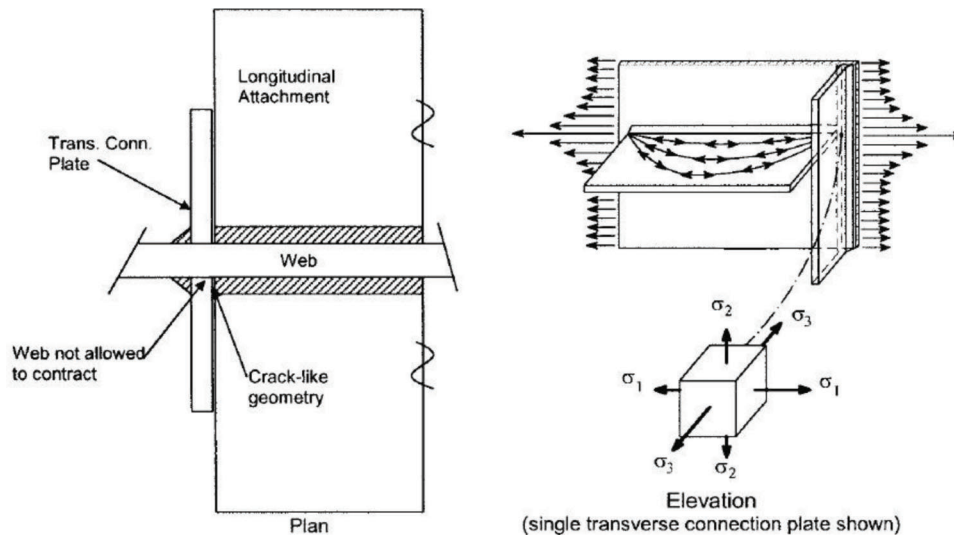
Figure 7.4 Illustration of effect of web gap size and constraint on the stress condition at the weld termination with the web gap (Connor *et al.*, 2007).

Figure 7.4 provides an illustration of the mechanics behind the three contributing elements for CIF. This figure shows a plan view and elevation view of a welded detail where the longitudinal attachment to the web plate intersects with the transverse plate. Little or no web plate gap exists between the weld intersections. Due to the welded construction, high residual tensile stresses are present. Crack-like geometry amplifies stress concentrations by disrupting stress flow between the longitudinal and transverse plates forcing those stresses back into the web plate through the small area of intersecting weld. With the stress condition at the yield strength of the web plate, the material would attempt to contract in the through-thickness direction under live loading in order to disperse stress (i.e., Poisson's effect). However, the longitudinal attachments constrain the plastic flow of the web material subjecting it to what is called a triaxial state of stress, or plain strain condition,

the necking of the web plate in the plan view and the stress state of the infinitesimal cube in the elevation view. The third axis of stress, σ_3 , is diffused through necking of the material while stresses along the σ_1 and σ_2 axes have been shown to reduce by 26 percent and 36 percent, respectively, with a web gap size of 1/4 inch (Connor *et al.*, 2007; Mahmoud *et al.*, 2005).

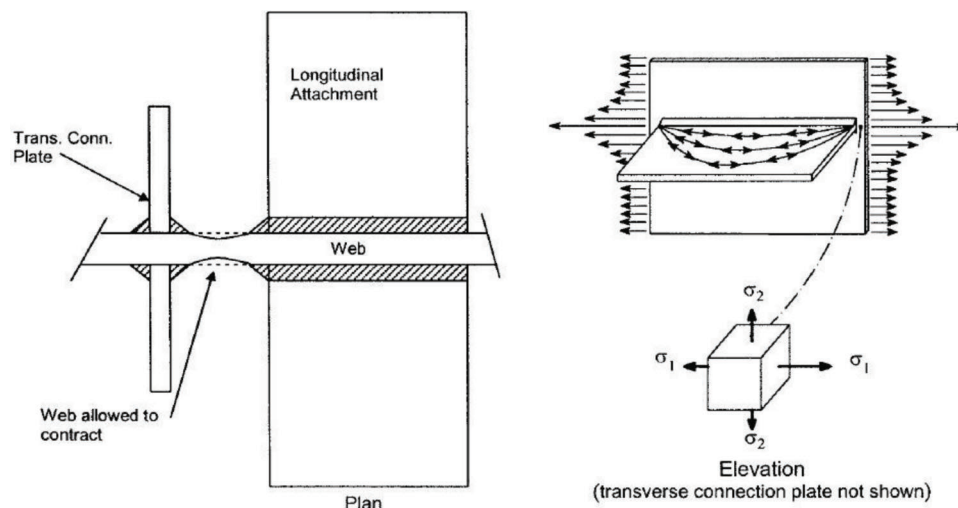
Figure 7.5 Illustration of effect of a sufficient web gap that removes constraint at the weld termination (Connor *et al.*, 2007).

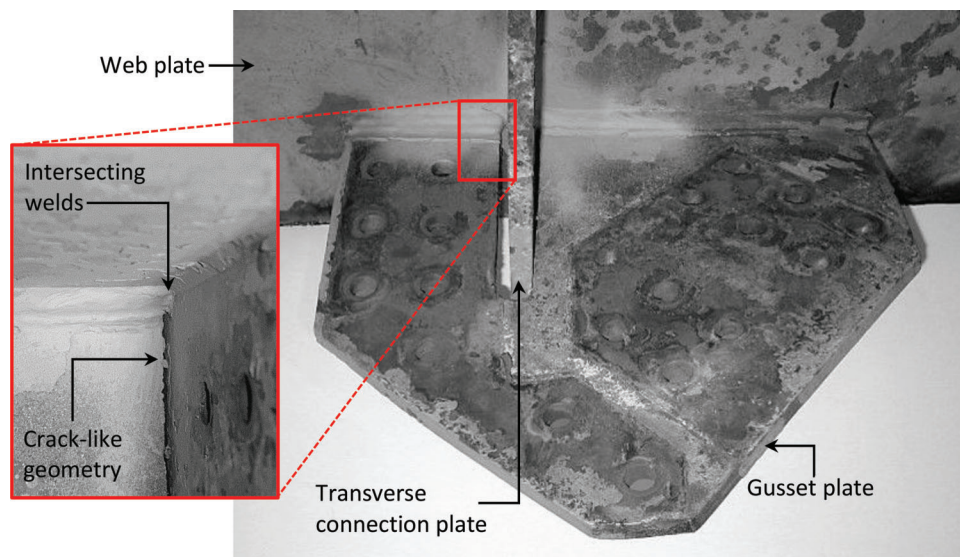
Figure 7.7 CIF detail located at the intersection of transverse and horizontal welds on the Hoan Bridge.

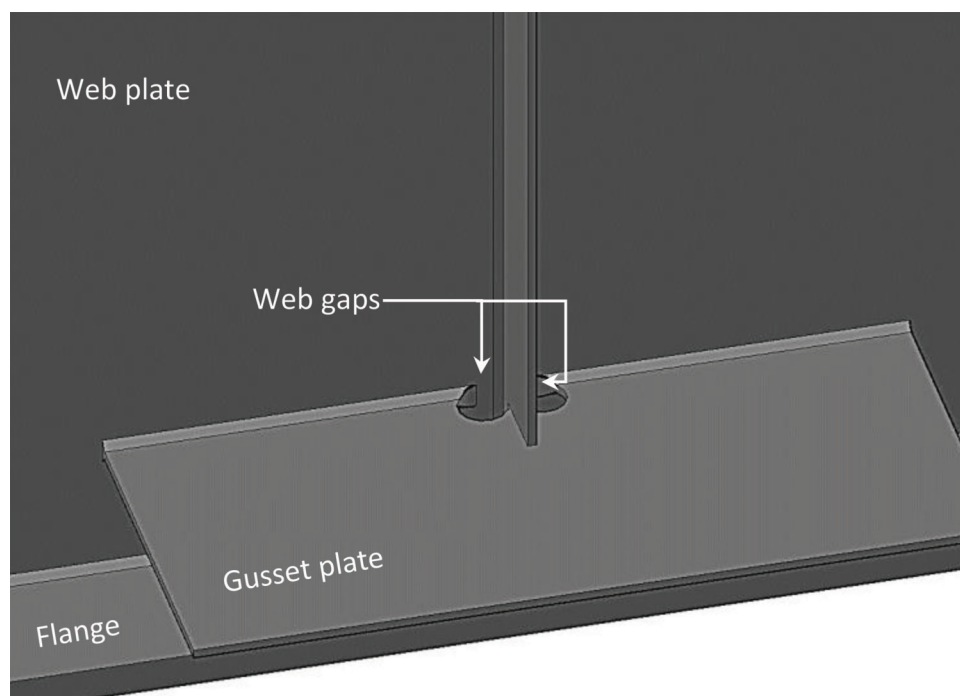
Figure 7.8 Gusset plate cope retrofit (secondary members removed for clarity).

(minimum of 1/4 inch of web exposed) to eliminate the localized constraint of the web plate. The retrofit is simple in concept, but can be challenging to implement based on the geometry of a detail. Figure 7.8 illustrates the simplest form of this detail with the secondary members removed for clarity, demonstrating the location of the copes adjacent to the transverse connection or stiffening plate.

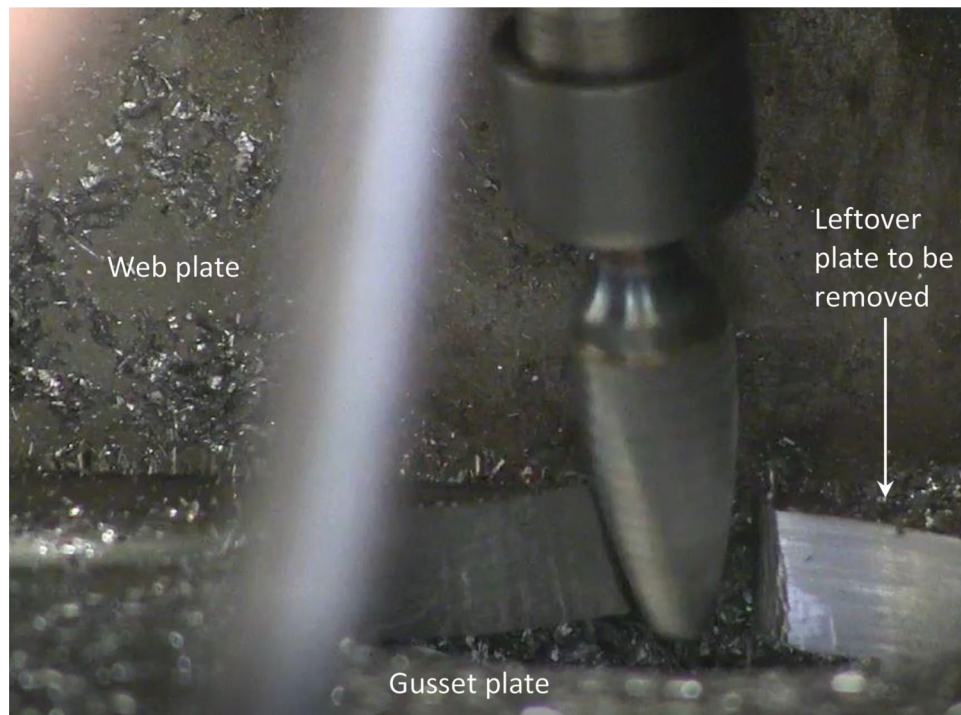
Figure 7.9 Burr grinder being used to remove leftover gusset plate and weld.

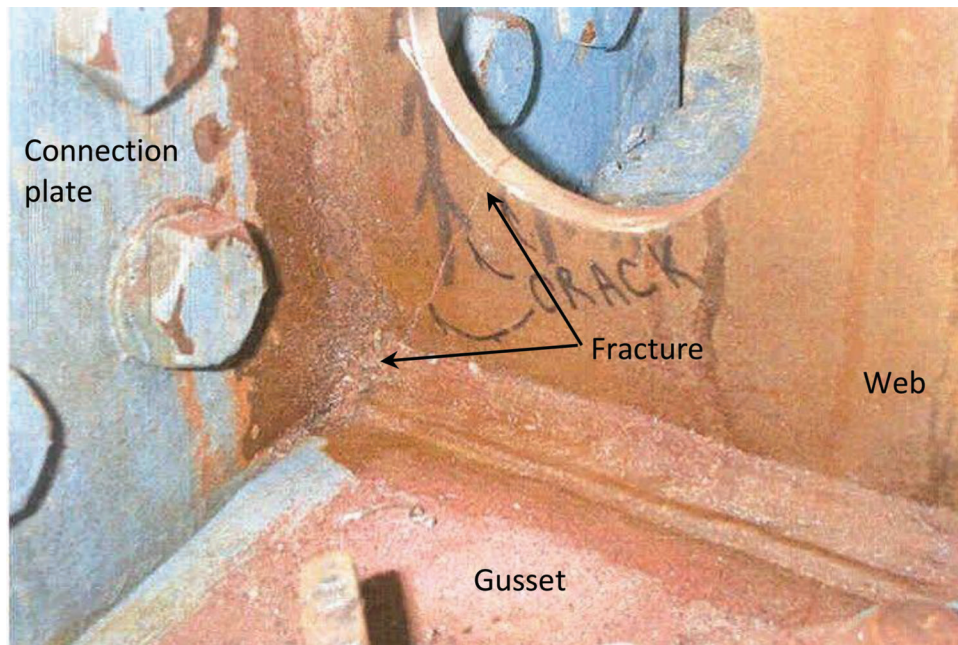
Figure 7.11 CIF arrested in one of the Hoan Bridge web isolation holes shortly after installation (Photograph courtesy of Phil Fish).

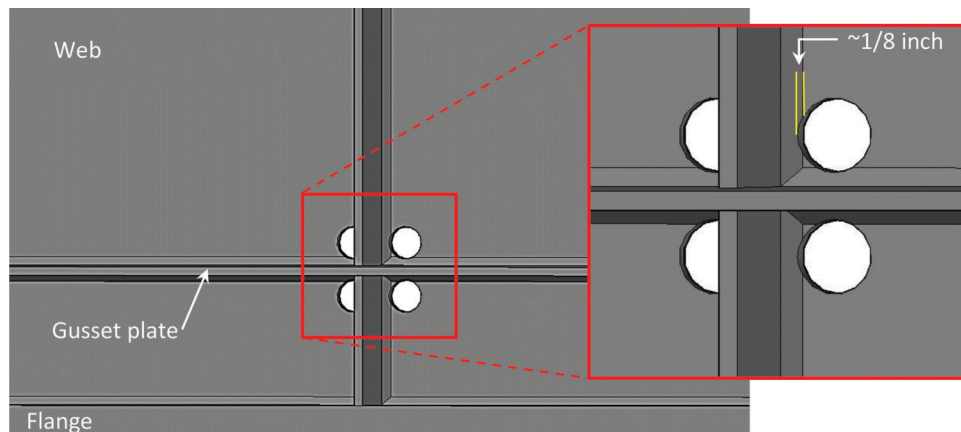
Figure 7.12 Web plate isolation holes retrofit for CIF details.

isolation holes” since its purpose is to isolate the girder from the potential fracture. Figure 7.12 illustrates this retrofit showing the four holes surrounding the CIF detail. Notice that the holes intercept the vertical and horizontal welds toes.

1. Determine the correct placement for the annular cutter ensuring that the drilled hole will intercept the vertical weld toe about 1/8 inch, as illustrated in Figure 7.12. If possible, also place the drilled hole so that it intercepts the horizontal weld toe, but if both cannot be achieved, the

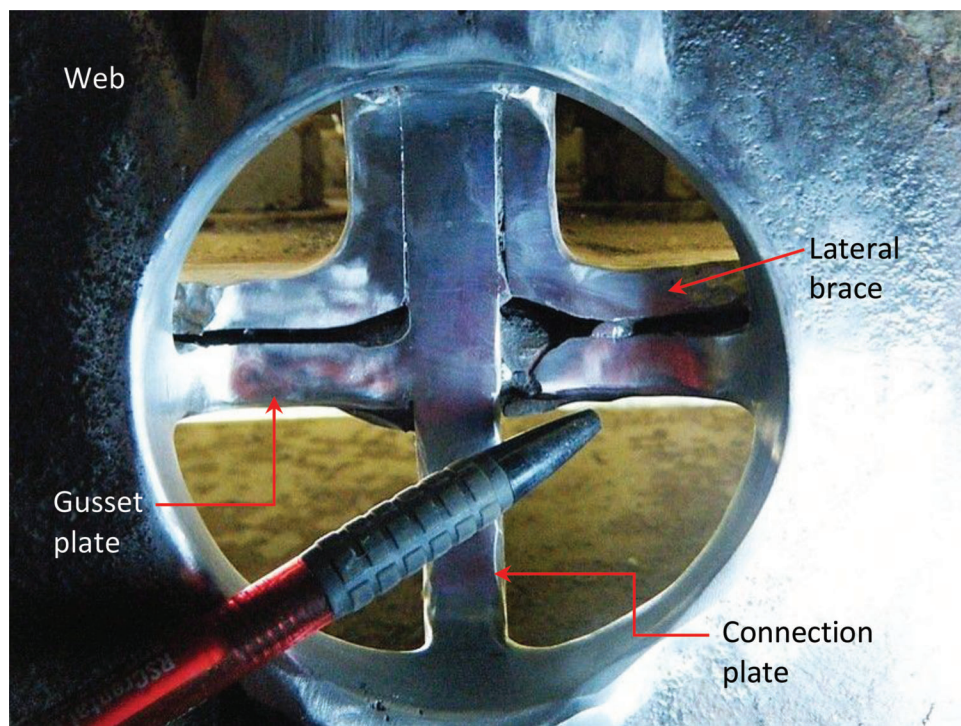
Figure 7.15 Ball end mill retrofit on Diefenbaker Bridge.

plate and the horizontal gusset plate crossing through the middle of the hole. The retrofit revealed that the gusset-to-connection plate groove welds had substantial incomplete fusion in a large number of the connections

suggesting that the risk of a repeat CIF would have been high had the repairs not been implemented bridge-wide (Ellis *et al.*, 2013). The lack of fusion is evident in Figure 7.15.

3. Inspect the hole placement to confirm that it removed all of the weld intersection. If the hole misses any part, use a carbide rotary burr bit with a die grinder to widen the milled hole. An open gap should be achieved on all sides of the intersection, as is seen in Figure 7.15 and Figure 7.16.

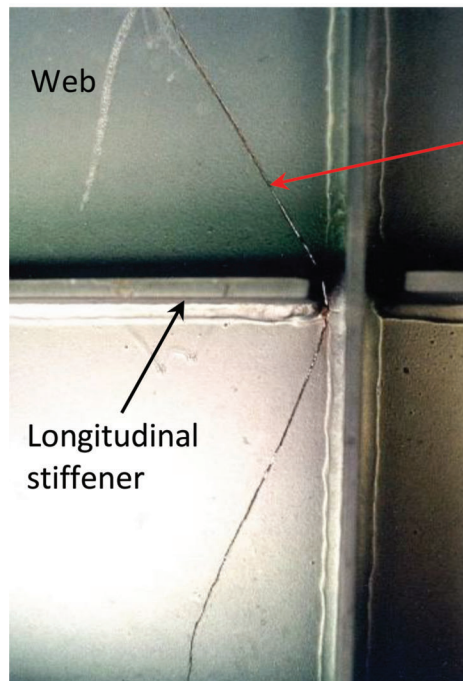
Figure 7.17 CIF at a longitudinal stiffener.

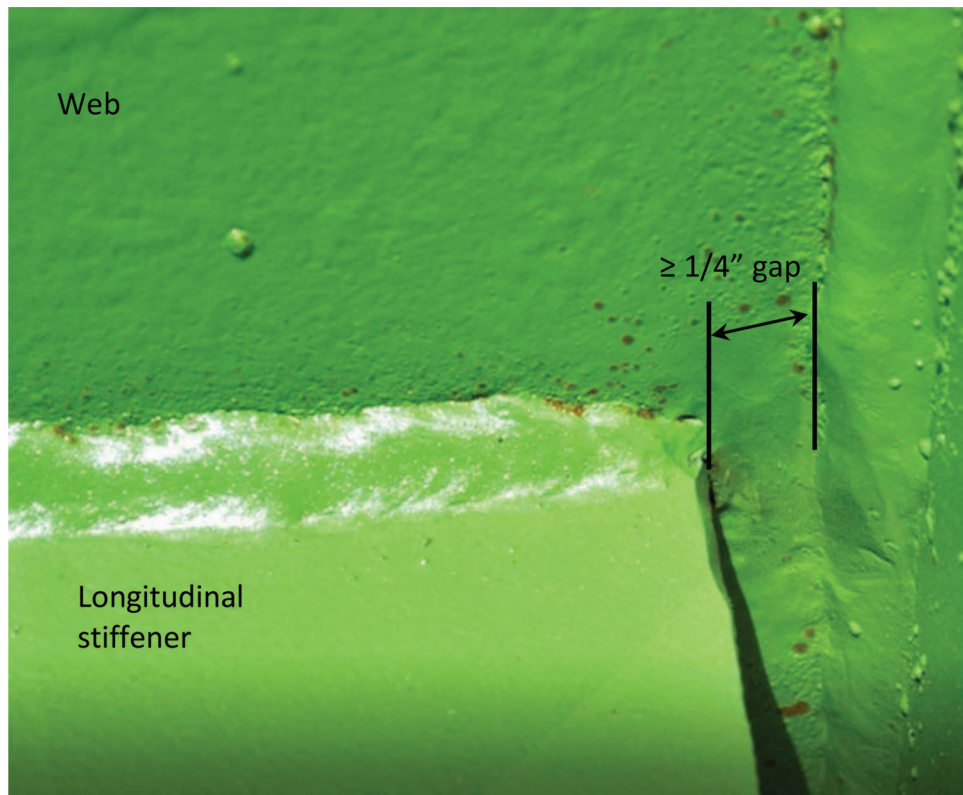
Figure 7.18 Example of CIF retrofit on longitudinal stiffener providing necessary 1/4 inch web gap.

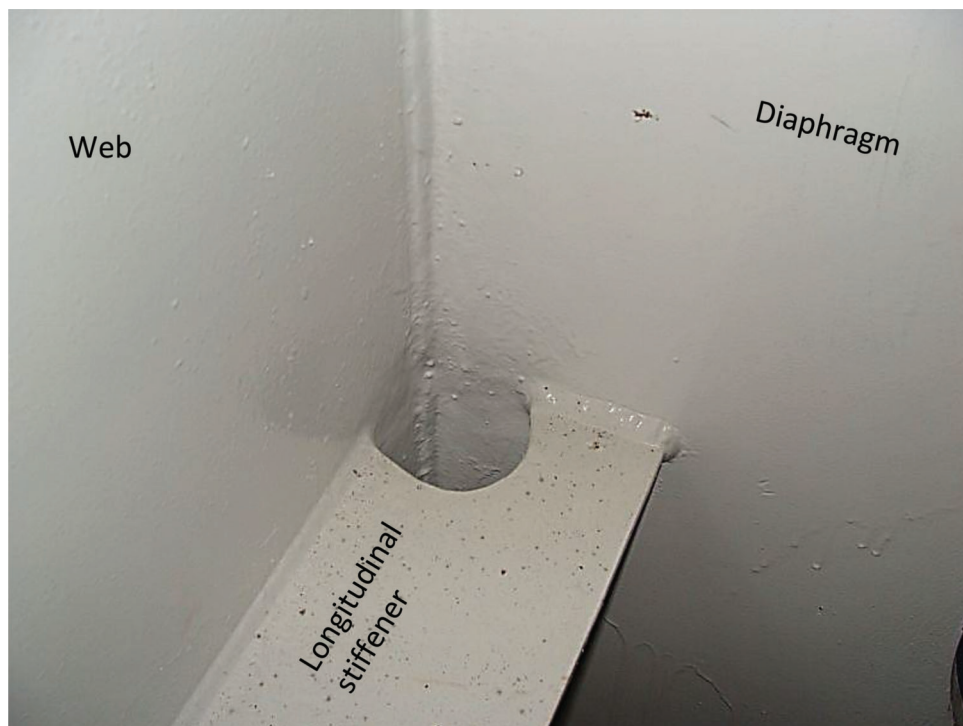
Figure 7.19 Hoan Bridge longitudinal stiffener CIF retrofit.

Section 7.1.2.1 where coring and grinding are used to create the cope at the corner of the intersecting plates. An example of this is shown in Figure 7.19; taken from the Hoan Bridge inside the tie girder span.

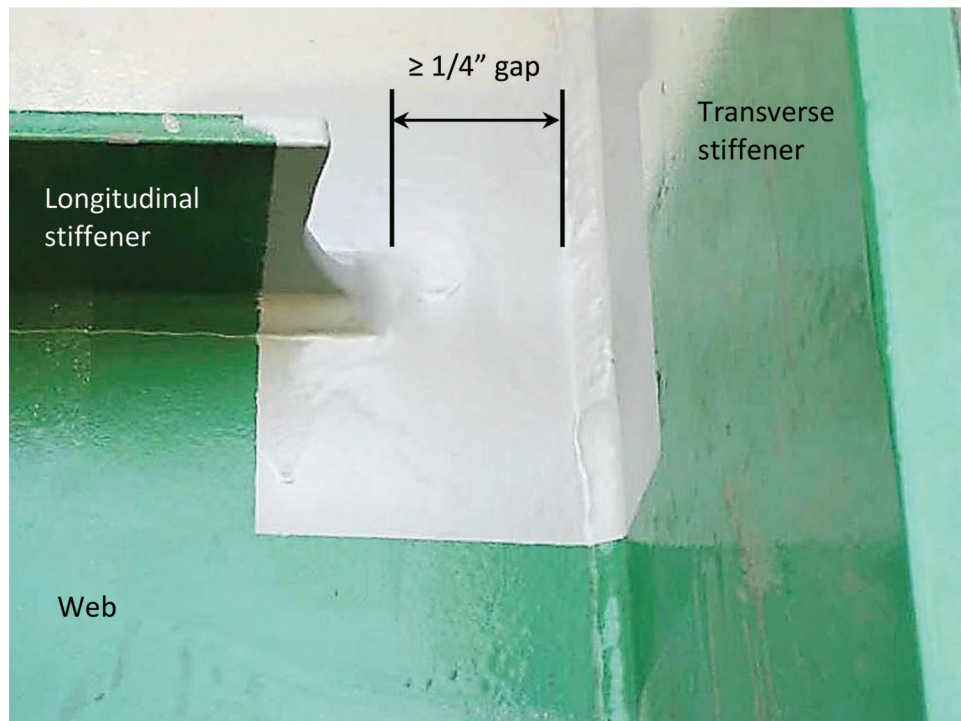
Figure 7.20 CIF retrofit at a longitudinal stiffener (Photograph courtesy of Iowa DOT).

Figure 7.20 shows another approach to the same retrofit that is often used. This image was taken of CIF retrofit work performed on the I-80 Spring Street Bridge over the Missouri River near Council Bluffs, IA. This bridge had several locations in the negative moment regions where the longitudinal stiffener welds intersected the bearing stiffener welds creating potential for CIF. The cutback method produces a large web gap region removing the risk for CIF. By cutting the stiffener plate back, ample room is provided to ensure quality finish work can be accomplished within the new gap region. Additionally, increasing the radius at the end of the plate to 2 inches or greater will improve the fatigue resistance of the longitudinal weld termination, accordingly. This is an added benefit to the overall retrofit that adds very little cost.

4. With the web plate exposed within the new gap, check the gap dimension between the longitudinal and transverse weld toes (see Figure 7.20). *This gap must be a minimum of 1/4 inch, however, more is better.* If the gap is less than 1/4 inch, additional grinding with the carbide rotary burr bit and die grinder will be necessary.

7. Paint the repair area using recommendations provided in Section 4.2.
8. Figure 7.20 shows an example of the completed retrofit on one side of the transverse plate. This same procedure must be repeated on the other side of the transverse plate for a completed retrofit. Notice the smooth and gradual transition from the longitudinal plate to the web plate that helps to minimize stress concentrations at the weld termination, the preserved transverse weld, and the large, smooth web gap exposed between weld toes.

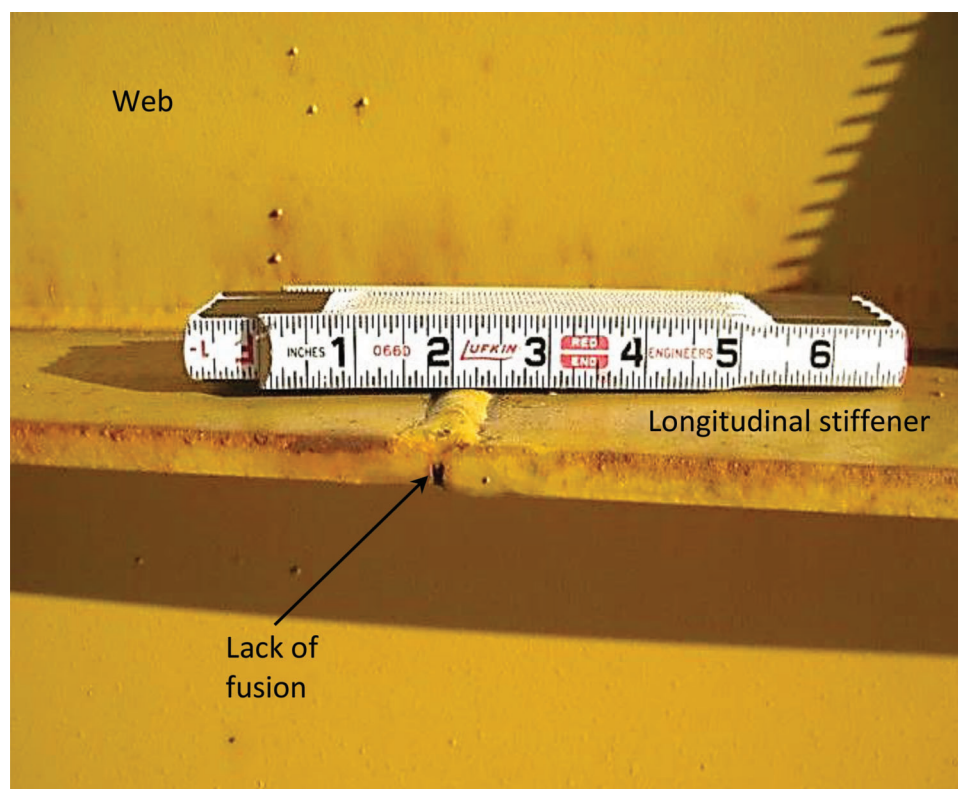
Figure 7.21 Example of poor quality longitudinal stiffener butt splice weld.

As stated, in the past these welds were not always considered to be of real importance since the stiffener was not viewed as part of the primary member, but rather, simply an ancillary attachment. As a result the quality would occasionally be overlooked. Figure 7.21 shows an example of this type of weld where the lack of fusion between the plates is clearly seen from the edge. In this case the plates do not appear to have been beveled, suggesting that they were simply butted flat together, welded to the web, and then fillet welded. These poor quality welds, particularly when located in stress reversal or tensile zones, are not only prone to fatigue, but there have also been fractures that have initiated without apparent fatigue cracking. Figure 7.22 shows another example of a poorly welded longitudinal stiffener splice. Here it appears that essentially no fusion was made in the splice, as if it were not welded at all. This configuration (as well as that seen in Figure 7.21) creates a crack-like geometry, much like what was discussed for Hoan details in Section 7.1, wherein the dead and live load stresses are forced around the

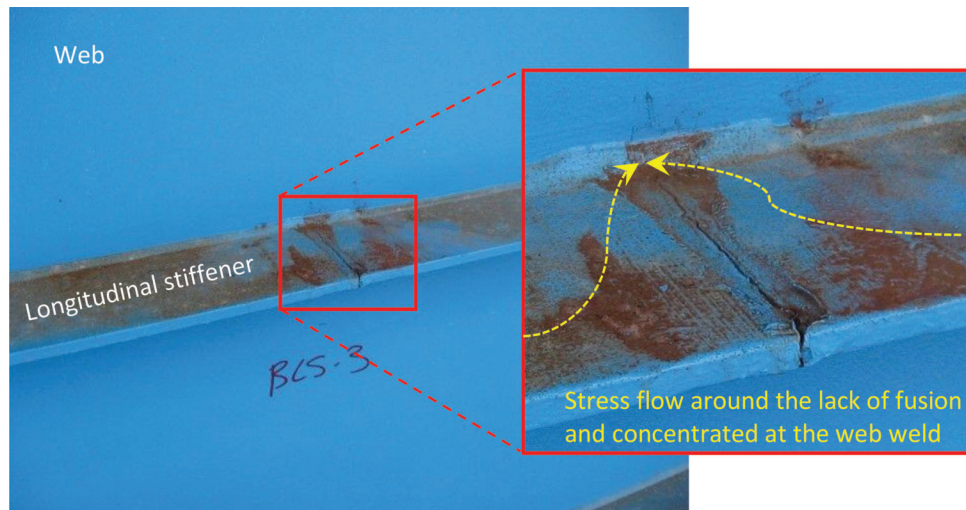
Figure 7.22 Poor quality longitudinal stiffener splice (shown before retrofit).

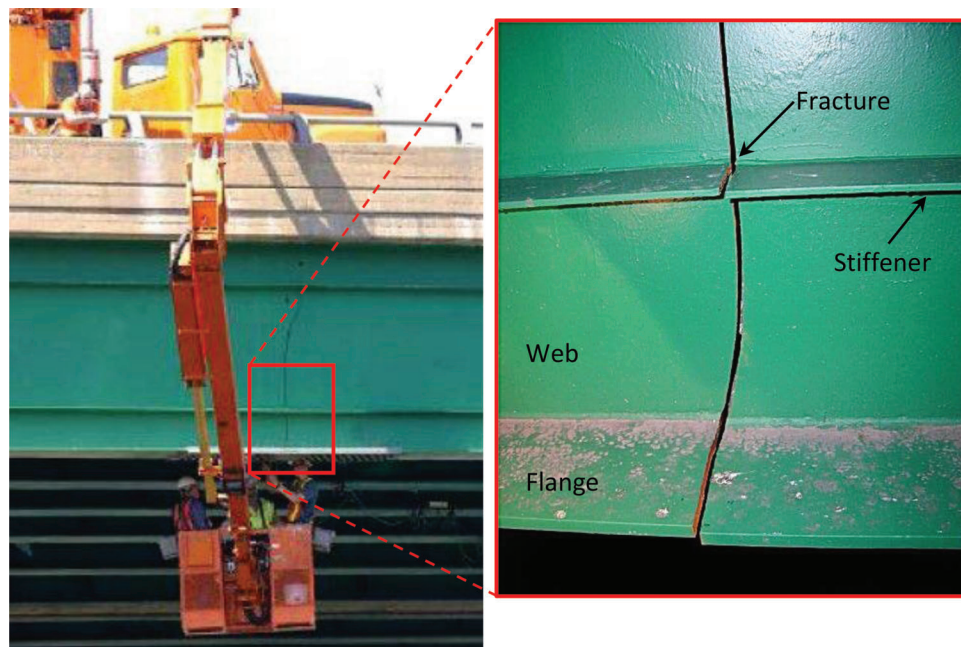
Figure 7.23 I-95 Bridge over Brandywine River in Delaware with fracture initiated at the longitudinal stiffener butt splice (Chajes *et al.*, 2005).

The I-95 Bridge over the Brandywine River is a continuous, three-span, twin structure with six plate girders each, built in 1963. In April of 2003, a bird watcher observed a large crack on one of the fascia girders. Officials were called on scene and found that the northbound bridge had a near full-depth fracture that originated in a welded butt splice of the longitudinal stiffener in the tension zone. It was determined by the investigation team that a combination of cool temperatures (near freezing), increased live loads on the shoulder of the bridge due to ongoing maintenance, and a lack of fusion zone at the butt splice contributed to the fracture. Evidence collected by investigators suggested that the fracture was relatively recent and that the crack progressed rapidly due to brittle fracture and not due to fatigue (Chajes *et al.*, 2005). Figure 7.23 shows a couple of pictures where the fracture can be seen running through the tension flange, stiffener, and most of the web. A bolted splice was installed at the location of the fracture. Thorough inspection of similar details on the Brandywine River Bridge revealed a wide range of weld quality and workmanship, as well as a few more cracks in the butt splices. All of the longitudinal butt

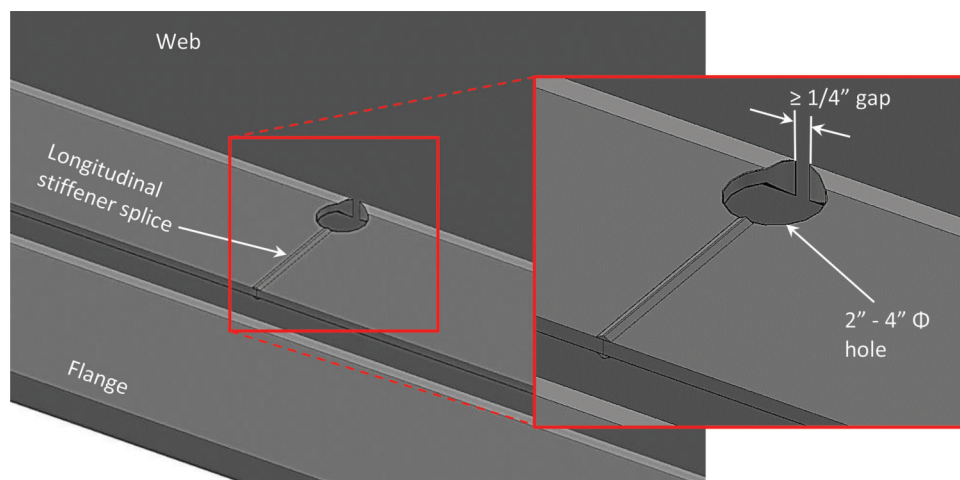
Figure 7.24 Illustration of the longitudinal stiffener core retrofit.

There are several varieties of this retrofit that have been implemented by DOT's throughout the country. Some remove more of the longitudinal plate than others, which won't make the retrofit more successful at its primary objective, fracture isolation, but may provide a particular aesthetic look that the owner prefers. The method that is presented here is a method that is relatively feasible to implement (i.e., minimal labor and skill involved) while providing effective and low-maintenance performance. Figure 7.24 shows the longitudinal stiffener core retrofit as described in the following

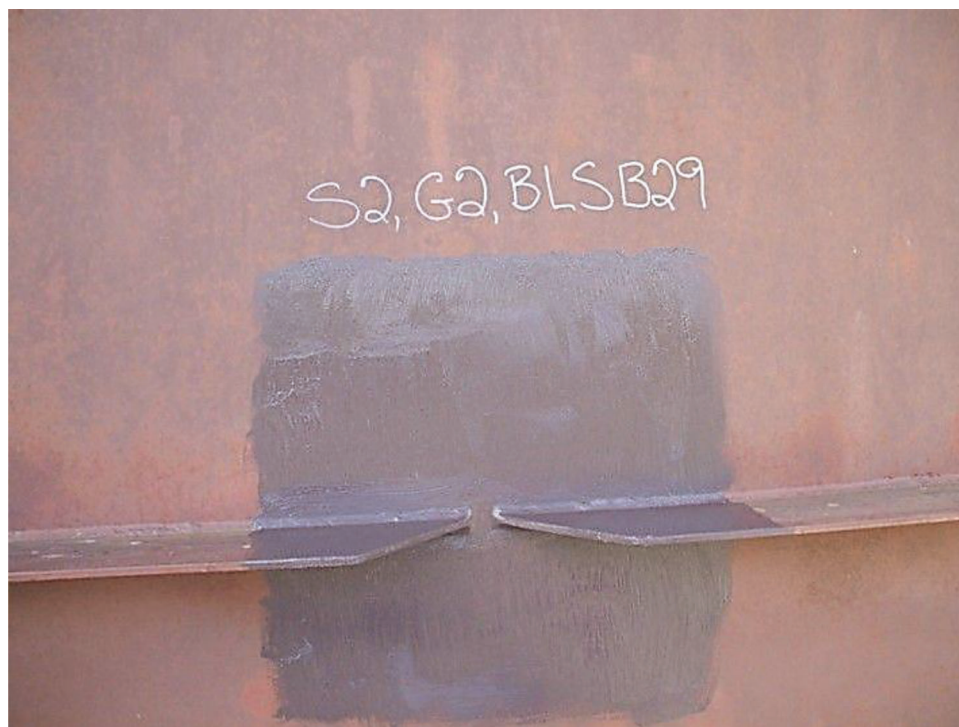
Figure 7.25 Alternate version of the longitudinal stiffener core retrofit with the stiffeners plates cut back in addition to the drilled hole.

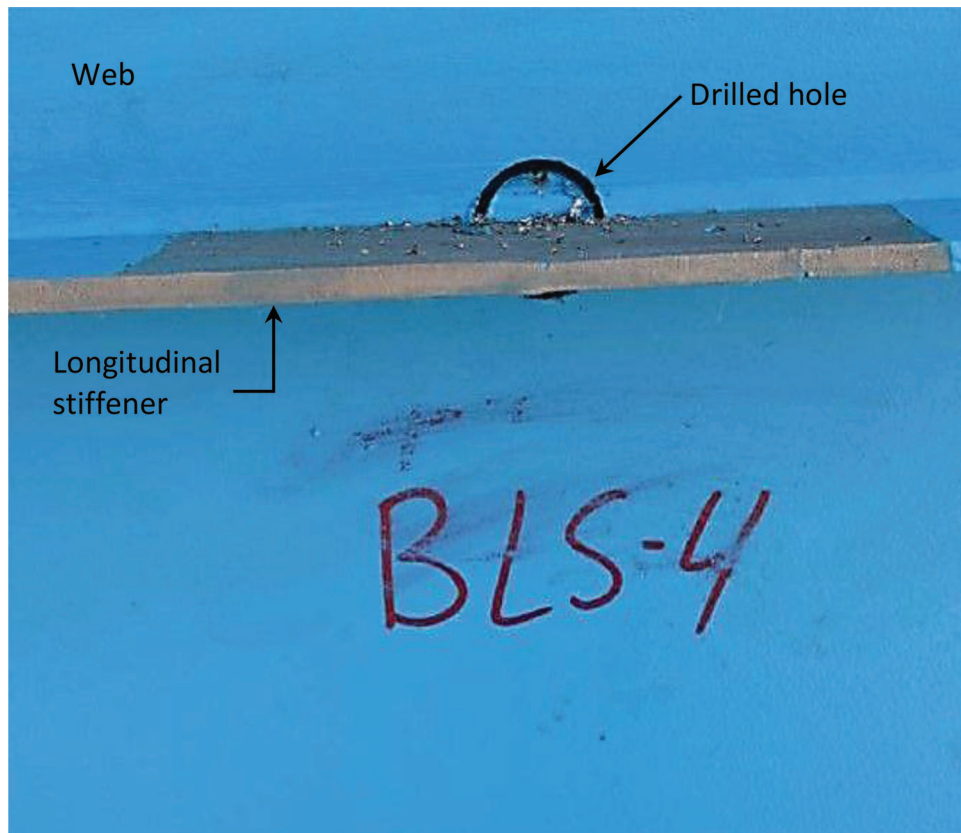
Figure 7.27 Hole drilled in web for web core retrofit.

5. Using a mag-based drill with annular cutter, drill a hole through the web plate and partially into the longitudinal stiffener plate, as shown in Figure 7.27. It is recommended to use a 2 to 4 inch diameter cutter to help reduce stress concentration and improve finish work.

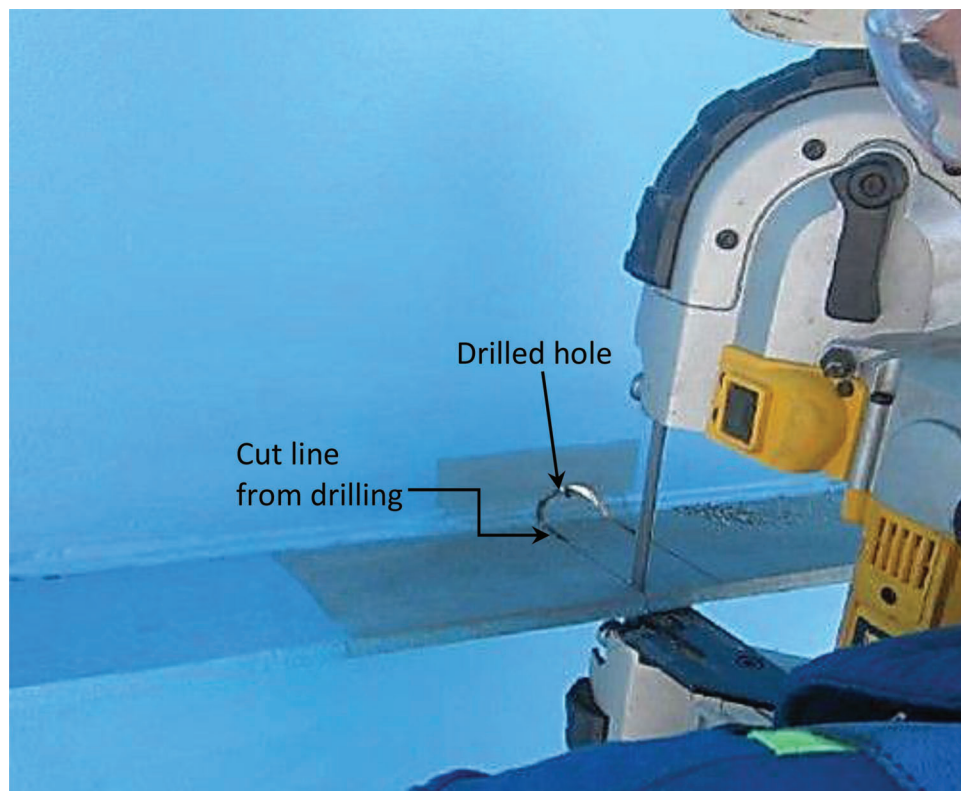
Figure 7.28 Removal of butt weld and drilled core for web core retrofit.

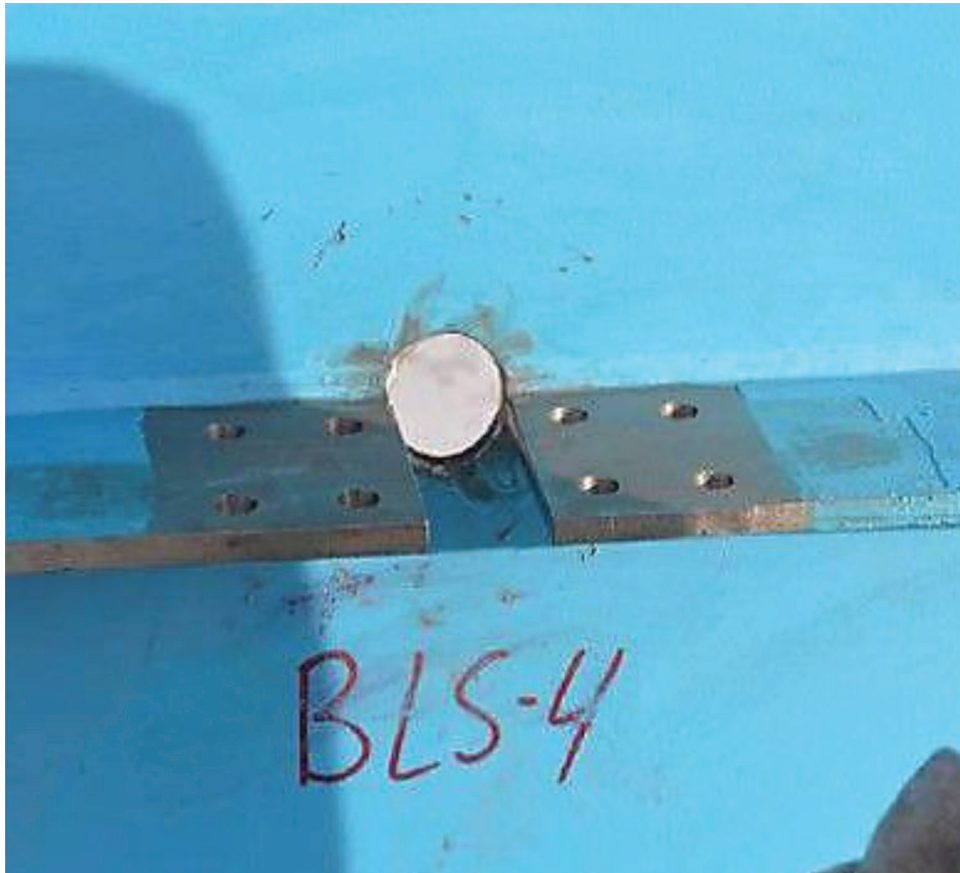
Figure 7.29 Finished retrofit with drilled holes for optional bolted splice.

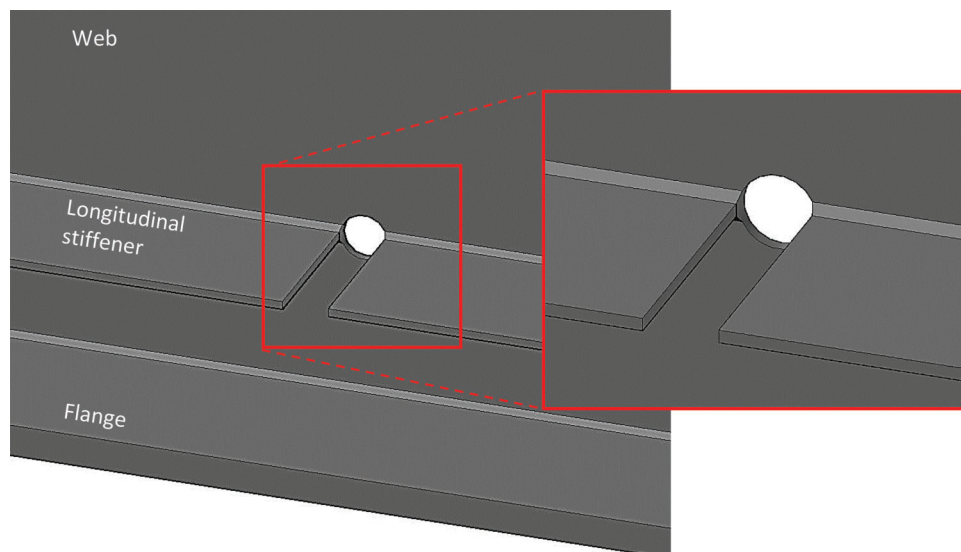
Figure 7.30 Illustration of the web plate core retrofit for longitudinal stiffener splices.

Figure 7.30 shows the completed web plate core retrofit (minus the bolted splice) for poor longitudinal stiffener butt splice details. The fatigue resistance of the new detail is governed by the drilled hole since the longitudinal welds terminate at the edge of the hole. The hole is at a minimum an AASHTO Category D detail, but may likely perform better if high quality edge conditions are put in place. Adding a bolted splice on

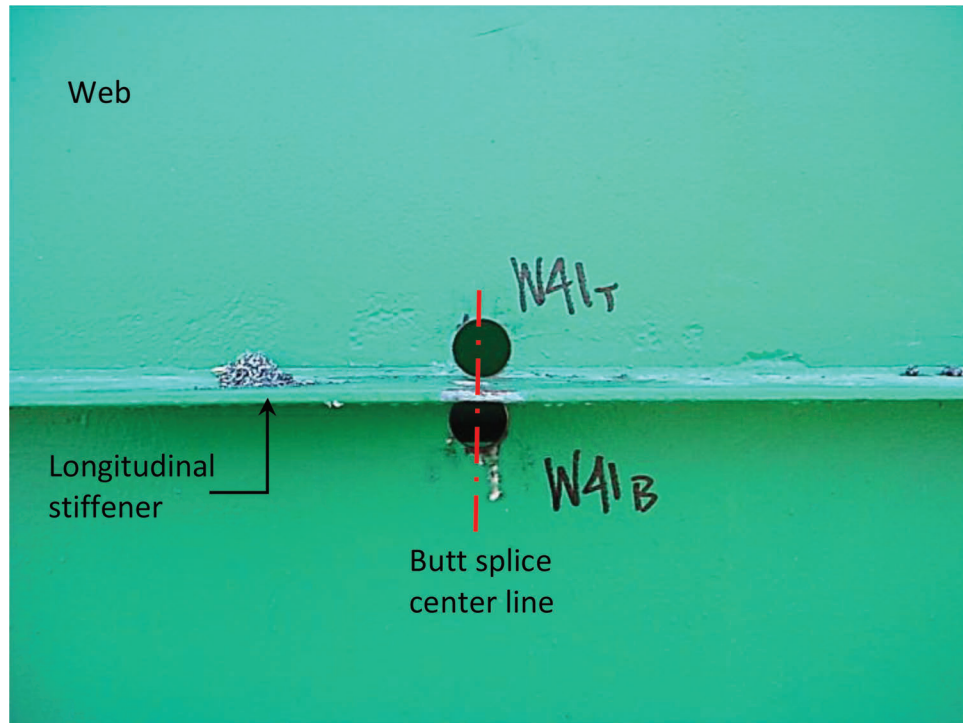
Figure 7.31 Alternate version of the web plate core retrofit (Chajes *et al.*, 2005).

Additionally, Figure 7.31 demonstrates a very simple alternative. This method uses isolation holes drilled in

the web plate directly above and directly below the longitudinal stiffener splice to arrest fracture if it occurs. The same sanding finishes would be recommended once the two holes are drilled. Although this retrofit may not be as aesthetic, it would effectively perform the intended function, is very economical, and could be installed even at locations with stiffeners on both sides of the web plate.

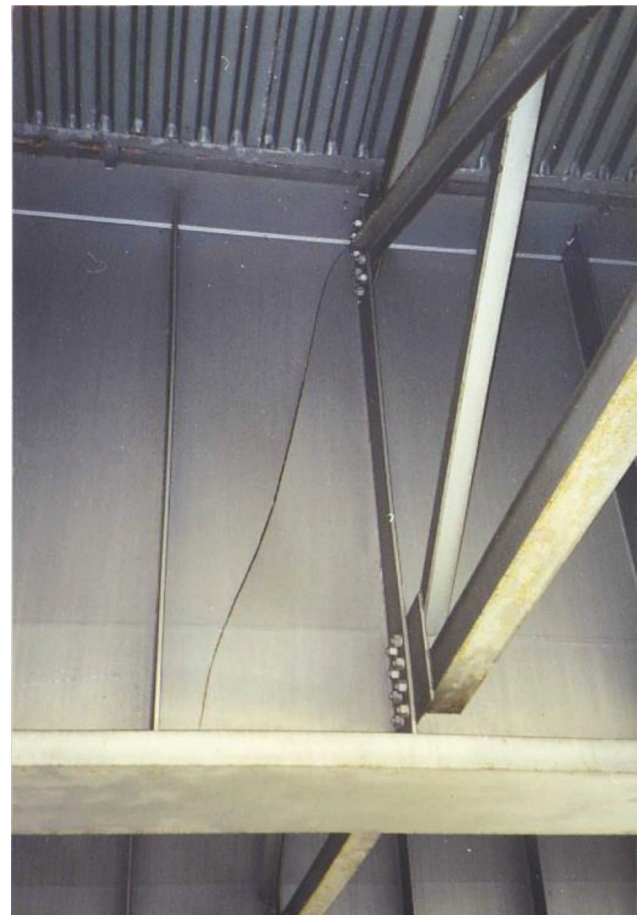
Figure 7.32 Fracture initiated at stiffener in negative moment region (Photograph courtesy of Y. Edward Zhou).

Several cases of brittle fracture initiating at the top of a bearing stiffener (or sometimes from connection plates) in a negative moment region of continuous spans have been observed. Figure 7.32 shows one such example from a bridge carrying I-495. This type of fracture, however, is much less common and there may be a number of undocumented cases. The actual cause of the fracture, meaning the characteristics that make one detail more prone than another, have not been well quantified by research or field studies. It is believed that some contributing factors are those that would contribute to a triaxial stress state at a subsurface microscopic flaw, such as the thickness of the stiffener element, the size of the longitudinal and vertical welds, the quality of the welds, and the size of the web gap. It is worth noting that no such fracture is known to have occurred when the stiffener/connection plate or bearing stiffener was welded to the flange.

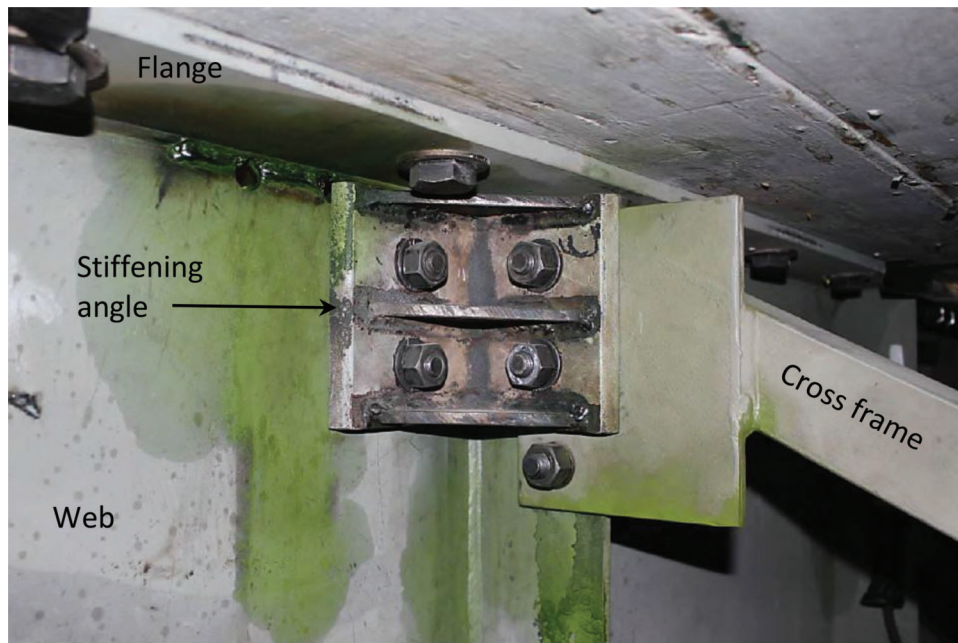
Figure 8.2 Stiffened-angles-with-plate retrofit (Taken from Bennett *et al.*, 2014).

The doubler plate-angle type retrofit has potential to work well in some applications when meticulously designed and installed. Bennett *et al.* (2014) found some positive results with highly stiffened angles and backer plates (see Figure 8.2). However, they also concluded that it was not as effective at mitigating crack initiation and propagation at the flange-to-web welds as connecting the stiffening component directly to the flange. This is because as mentioned above, the loads are still transferred through the web into the flange. Although the cost benefit of this type of retrofit is that the deck

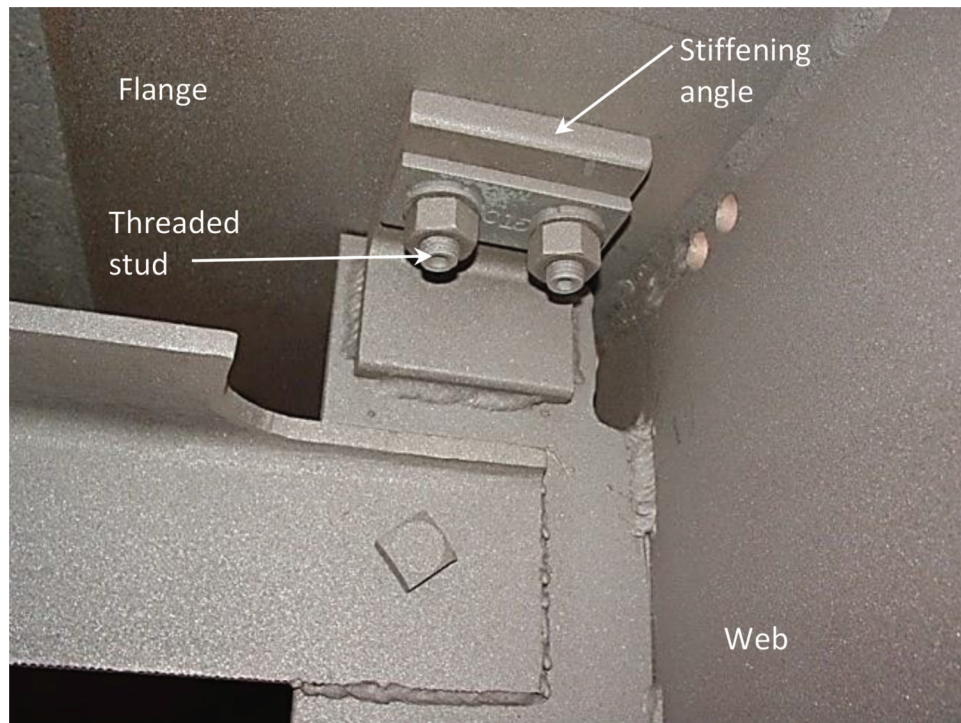
Figure 8.3 Example of fusion welded threaded stud retrofit shown blast cleaned in preparation for painting (Photograph courtesy of Kansas DOT).

Figure 8.3 shows an example of this type of retrofit that has been blast cleaned in preparation for painting. The threaded studs look like bolts from one side. In this example, the owner correctly drilled holes at the crack tips to arrest propagation and welded the stiffening angles to the connection plate providing a very stiff connection. The threaded stud connection to the flange, however, would not provide comparable stiffness, particularly because only two studs were used per angle. The threaded studs can be found commercially produced up to 1 inch diameter. However, the studs are not of comparable yield strength to the high strength structural bolts used for slip critical connections. Currently,

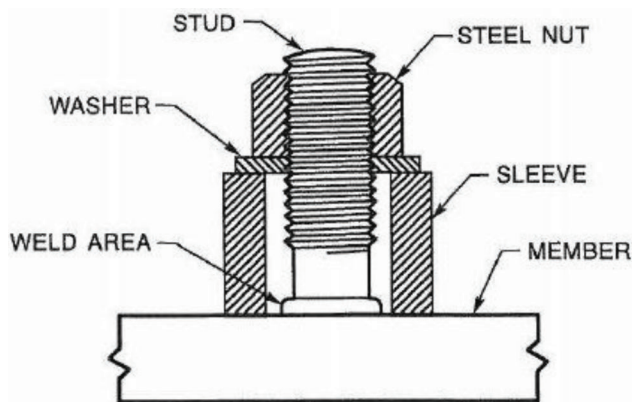
Figure 8.4 Torque testing arrangement (AWS, 2015).

The welding of studs during bridge fabrication is governed by AWS D1.5 where the qualification requirements for welding the studs can be found. It would be prudent to follow these fabrication requirements for the retrofitting process in order to ensure a quality retrofit. AWS D1.5 (AWS, 2015) calls for a welding procedure specification (WPS) for each base metal, stud type, and position. Ten specimens in each process, base metal, and position are required to be tested by one of the following: bend, torque, or tension testing for each operator. A passing test qualifies both the process and the operator. AWS D1.5 (AWS, 2015) provides a table of testing torques, which for a 1-8 UNC threaded stud it calls for 318 ft-lbs of torque. The suggested test configuration is shown in Figure 8.4. This setup could also be used to test a required turn-of-nut application in order to qualify that type of pretensioning method for the installation of the retrofit.
